Partial Review and Independent EMP Test Results of IAN, LLC Equipment

Performed by SARA, Inc.

Test Report MIL-STD-188-125-2 HEMP Acceptance and Simulated Verification Testing of EMP POD Unit 1 and EMP RV Unit 1 at Glen Burnie, MD

January 2009

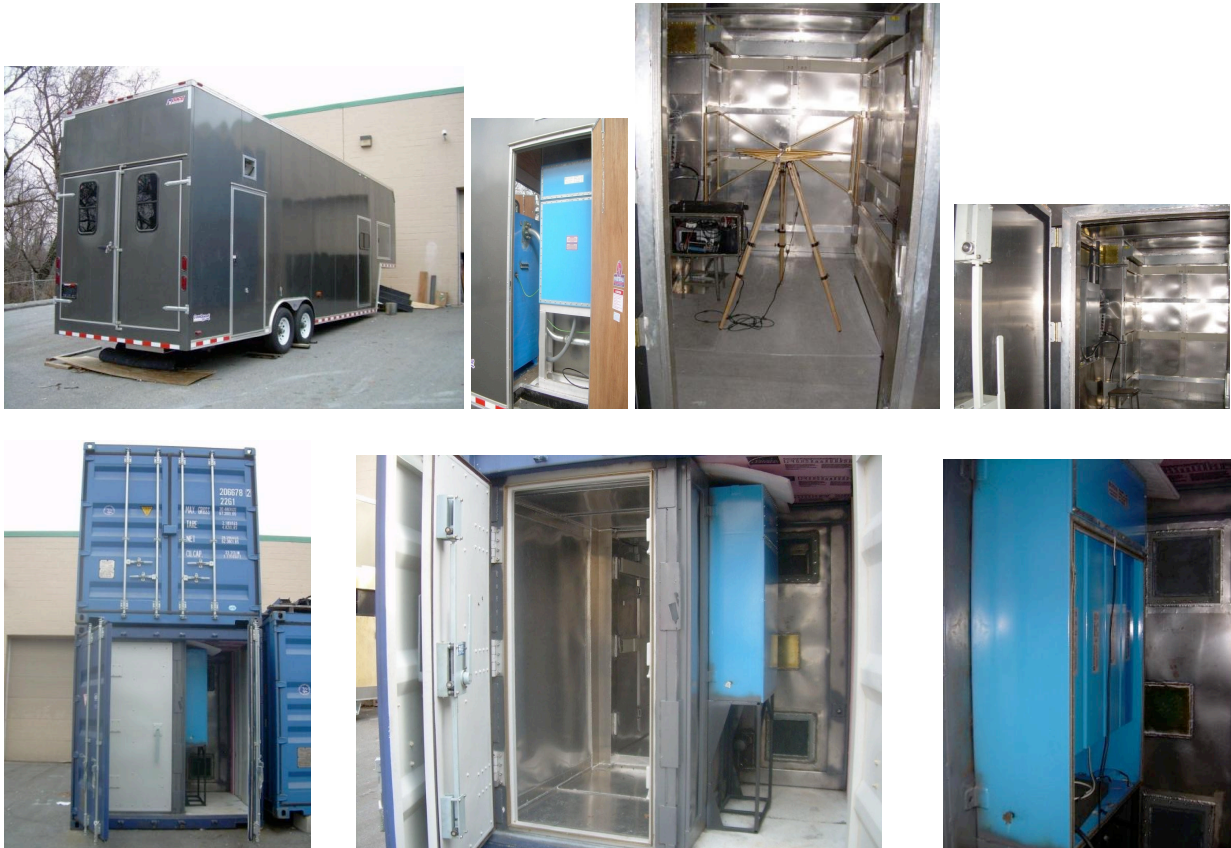
approximately 8x20ft inside the aluminum exterior. Two HEMP filters are installed toward the back of the EMP RV just outside the shield as shown in Figure 5-1. The HEMP filters provide protected main or generator power. The HEMP door is located at the front end with access from the side exterior door. There are two RF doors for entry inside the EMP RV, only the first main door is considered part of the shielded enclosure, the second RF door serves the same purpose as the aluminum layer which is to increase the shielding effectiveness of the entire Unit. The SE test had all exterior doors wide open in order to illuminate the EM barrier as best possible. There are fourteen test points located on sides, bottom and top. The EMP RV Unit 1 had all penetrations, filters and shield installed and completed when tested.”

“The EMP RV is the more mobile of the two shielded units and plans to contain mission critical equipment (MCE) for each individual specification as it pertains to their industry. The EMP RV shielded enclosure consists of two barriers, one thin steel layer and one thin aluminum layer. The entire shielded barrier is built inside the aluminum exterior body of the RV. The aluminum exterior outside shell contributes to the SE at the test points located furthest from the back or side door but is not part of the MIL-STD structure. The EM barrier is made of thin metal in order to reduce weight but have thick enough skin depth to effectively shield HEMP frequencies. The shield is
